RPS was commissioned by Donegal County Council to produce an Outline Invasive Species Management Plan (OISMP) for lands at Burnfoot, Castlefinn, Downings and Glenties in association with the proposed DB1 Donegal Flood Relief Scheme.

The proposed project is a flood relief scheme, with measures proposed in the towns of Burnfoot, Castlefinn, Downings and Glenties. While detailed flood relief measures are yet to be finalised, it is envisaged that such measures will involve the construction of hard engineered flood defence measures along watercourses among other potential options.

ECOLOGICAL SURVEY FOR BIRDS

Overwintering Wetland Bird Survey, Burnfoot and Inch Levels

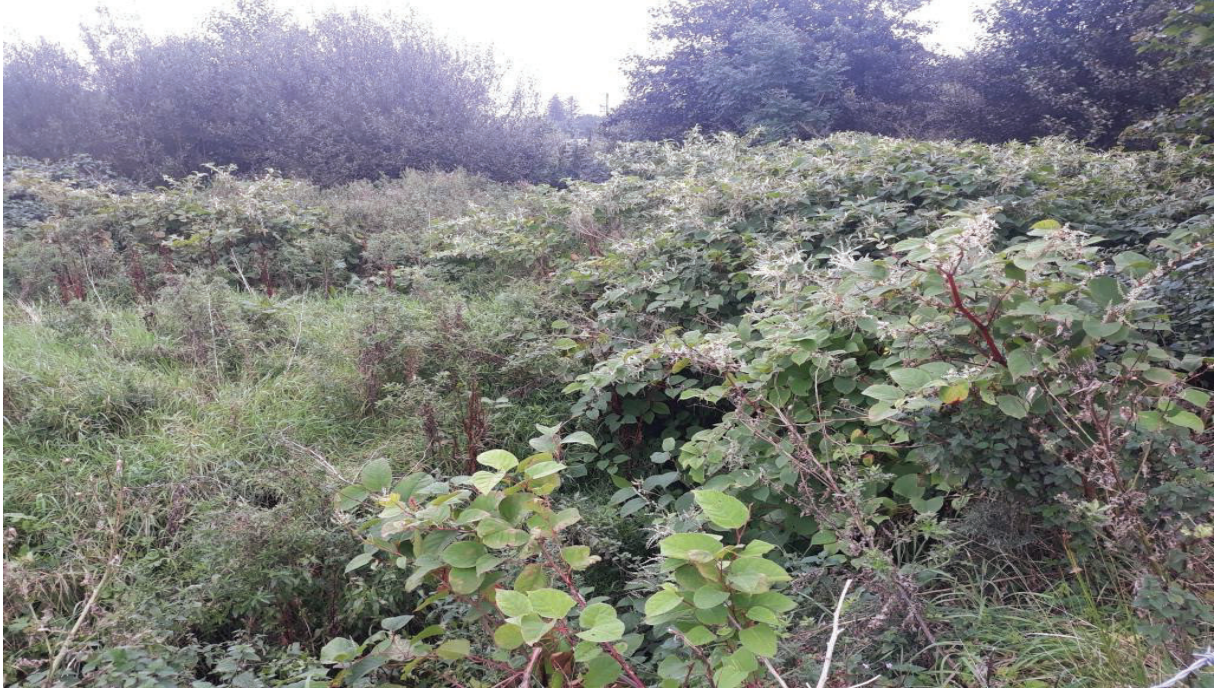
Plate 1: BJK01

Japanese knotweed was recorded in four separate stands within the Burnfoot survey area, including a large stand (c.30m²) on rough ground on the eastern bank of a small tributary of the Burnfoot River; a large stand (c.50m²), mostly on rough ground on the eastern bank of a small tributary of the Burnfoot River, although some was also located on the western bank outside the fence line of the improved field; and a small stand (c.5m²) on a bank to the rear of a house in Lios Na Greine on the southern side of the Burnfoot River.

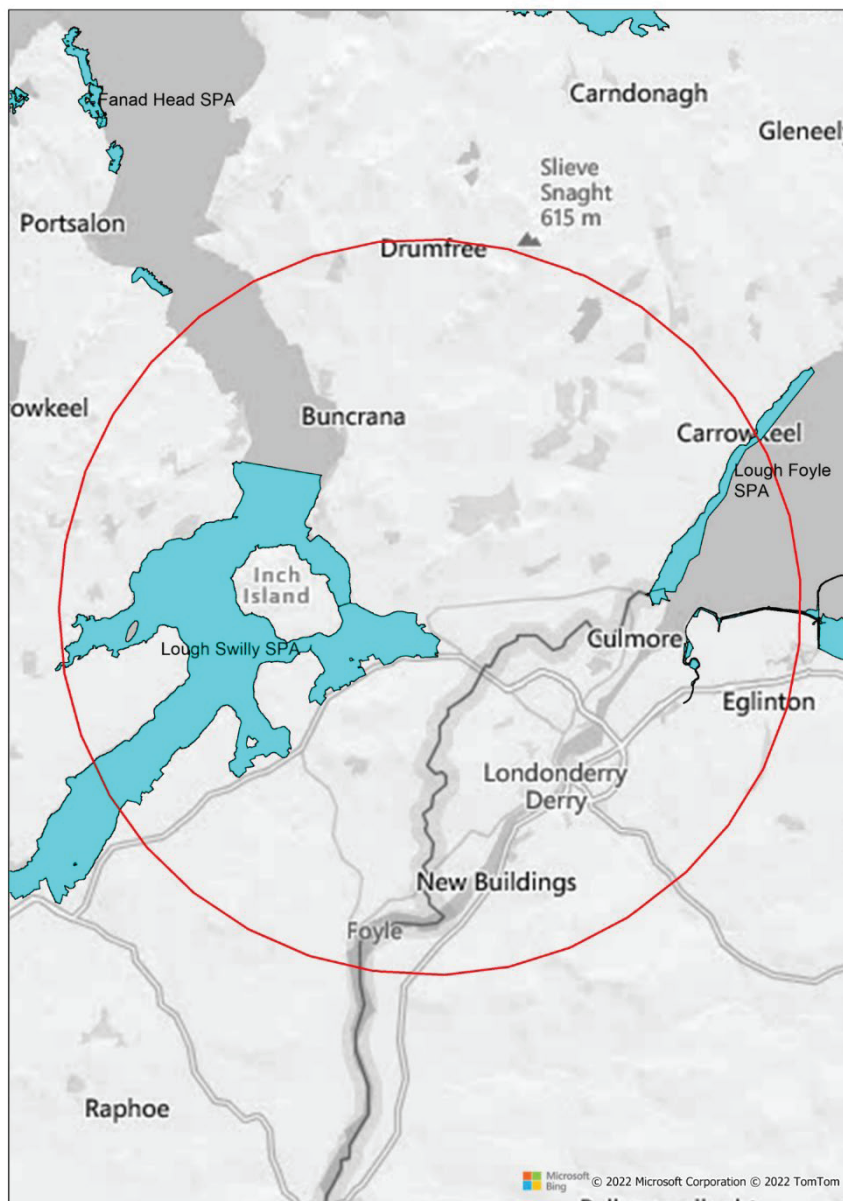
Figure 3.1: SPAs within 15km of the Proposed Development

Consultation of the NPWS Protected Species viewer shows three SPAs within the 15km of the proposed development, see Figure 3.1 below.

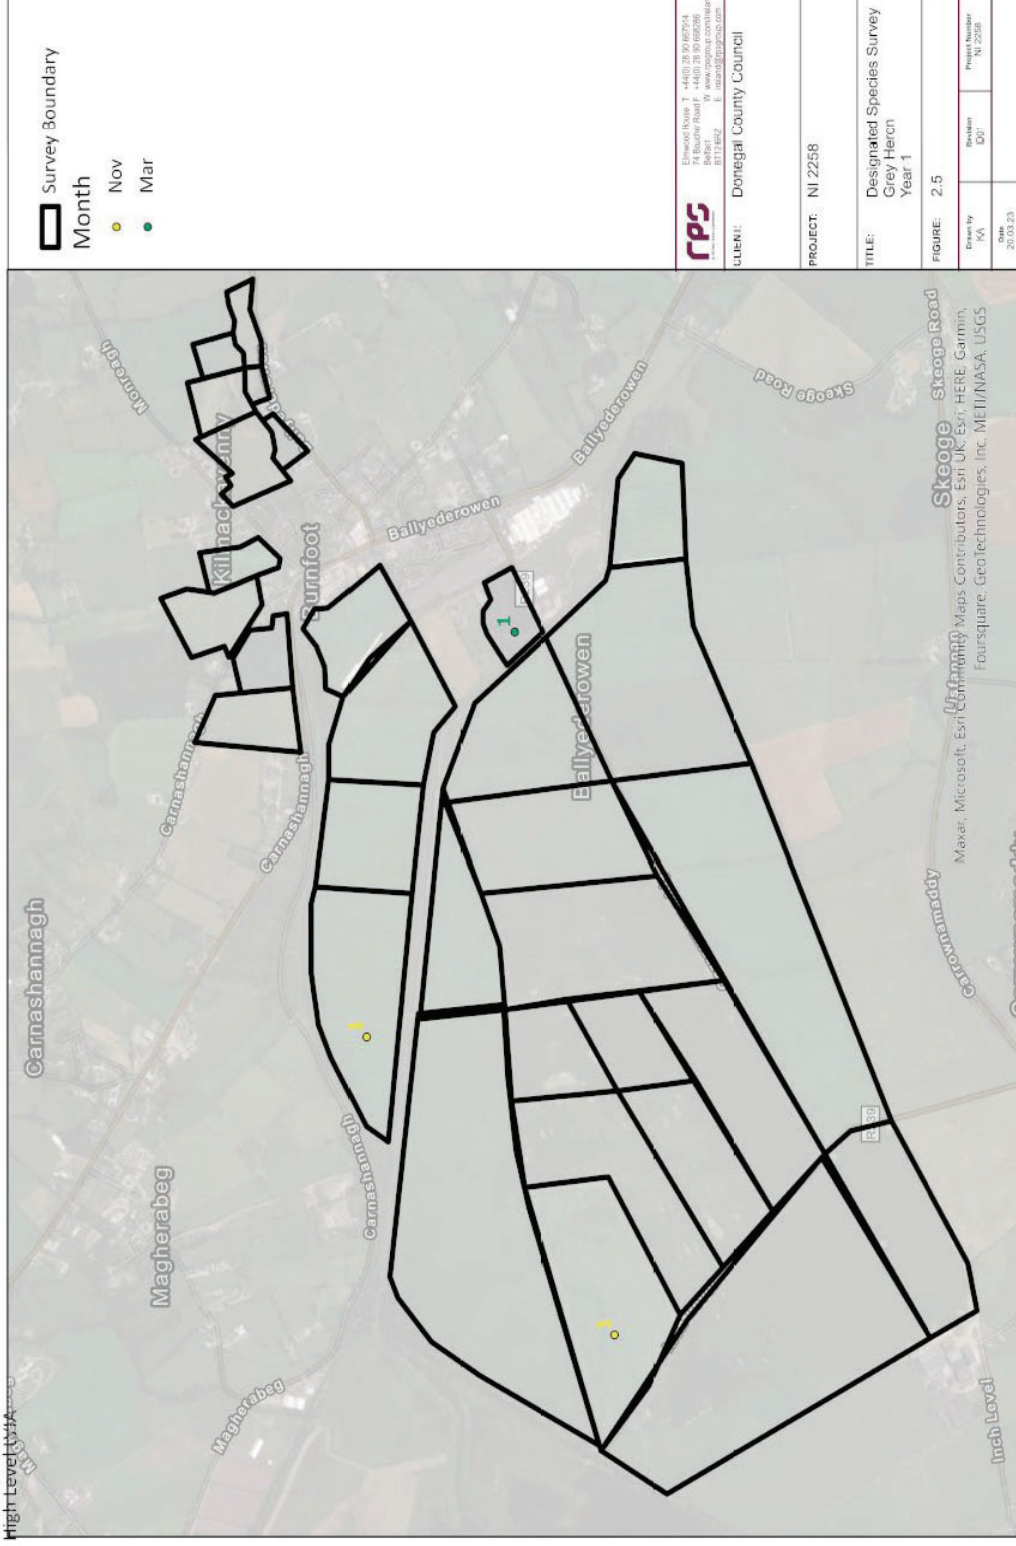
Client: Donegal County Council	
Project: NI 2258	
Title: Designated Species Survey Grey Heron Year 1	
Figure: 2.5	
Drawn by: KA	Project Number: NI 2258
Date: 20.09.23

Survey Boundary
 Month
 Nov
 Mar

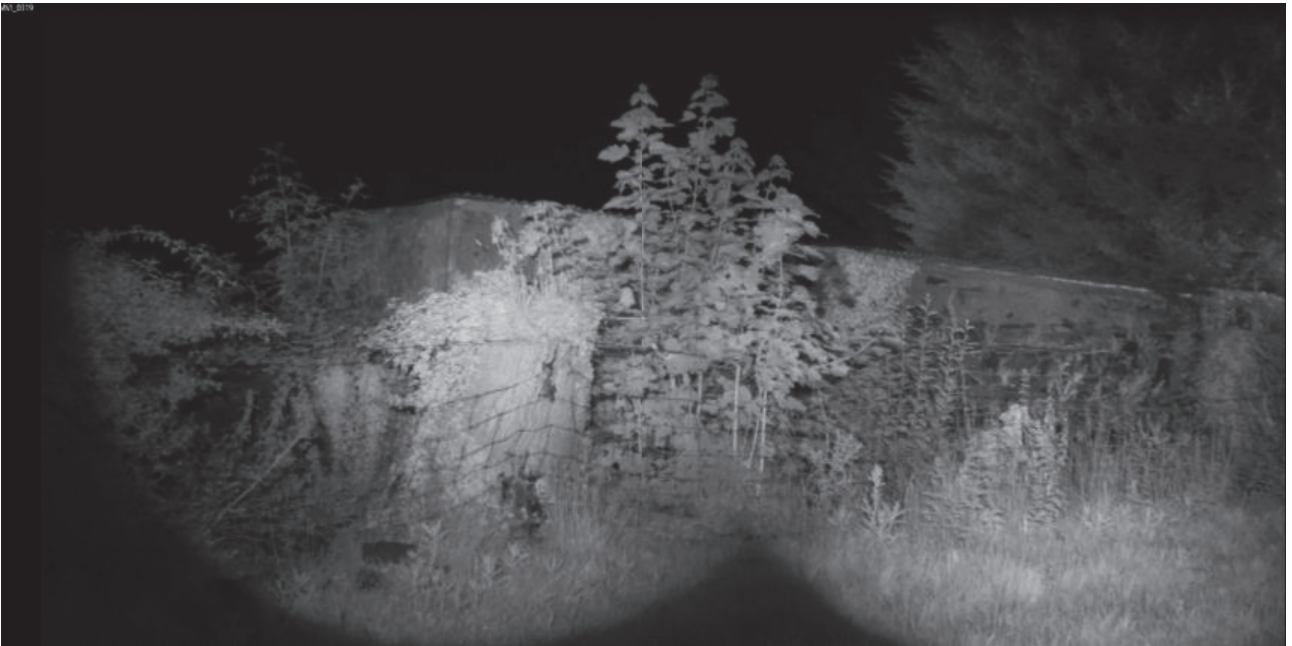
Plate 1 Screenshot from NVA to show field of view and illumination of Camera A

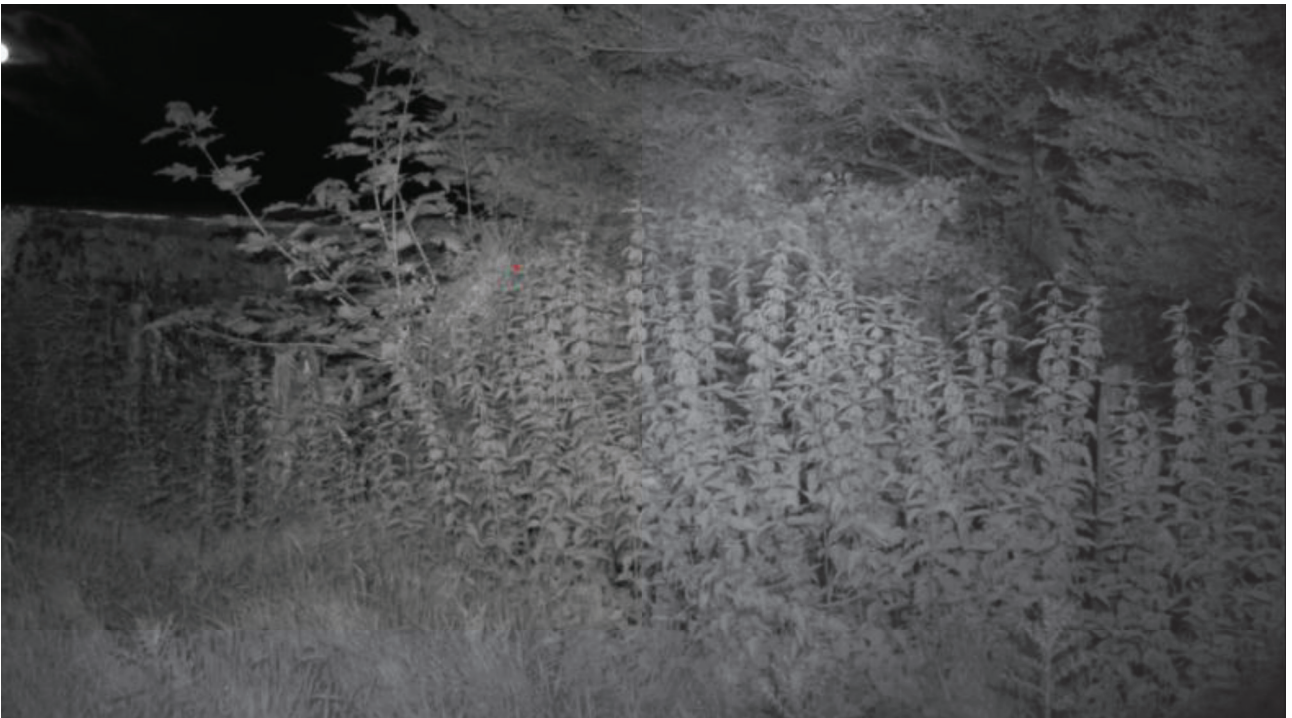
Plate 2 Screenshot from NVA to show field of view and illumination of Camera B

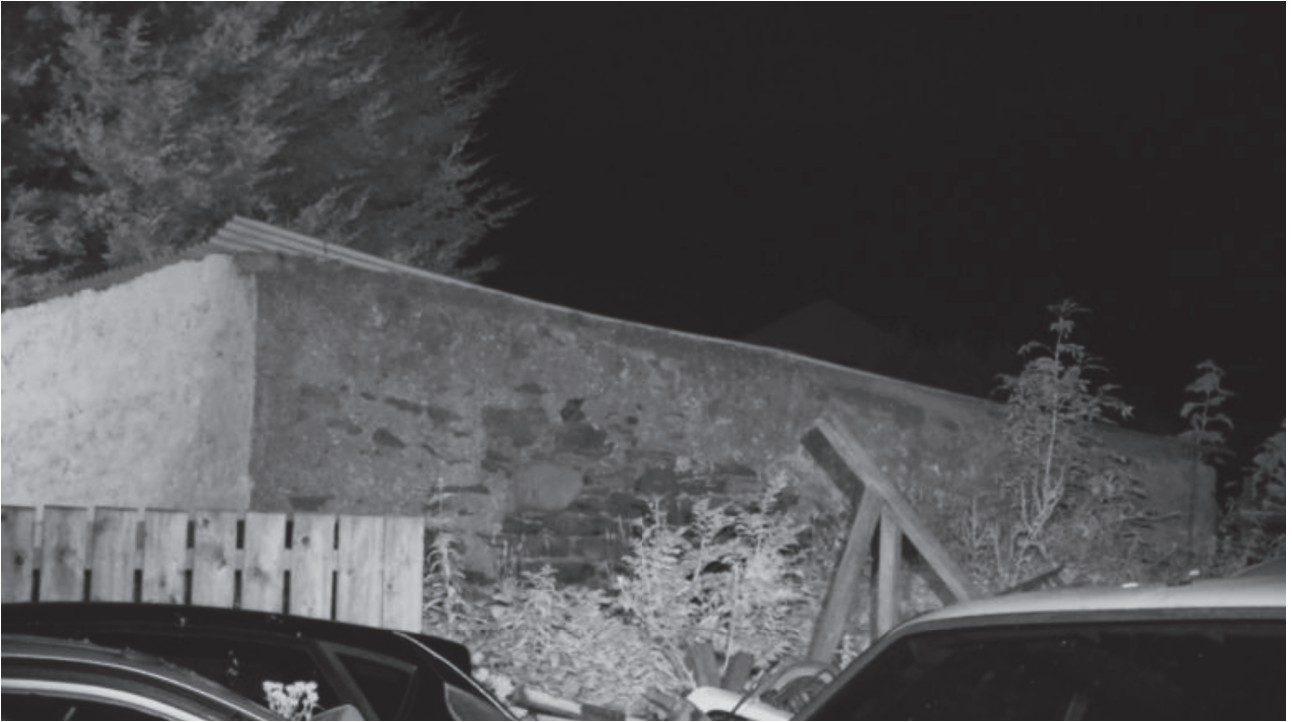
Plate 3 Screenshot from NVA to show field of view and illumination of Camera C

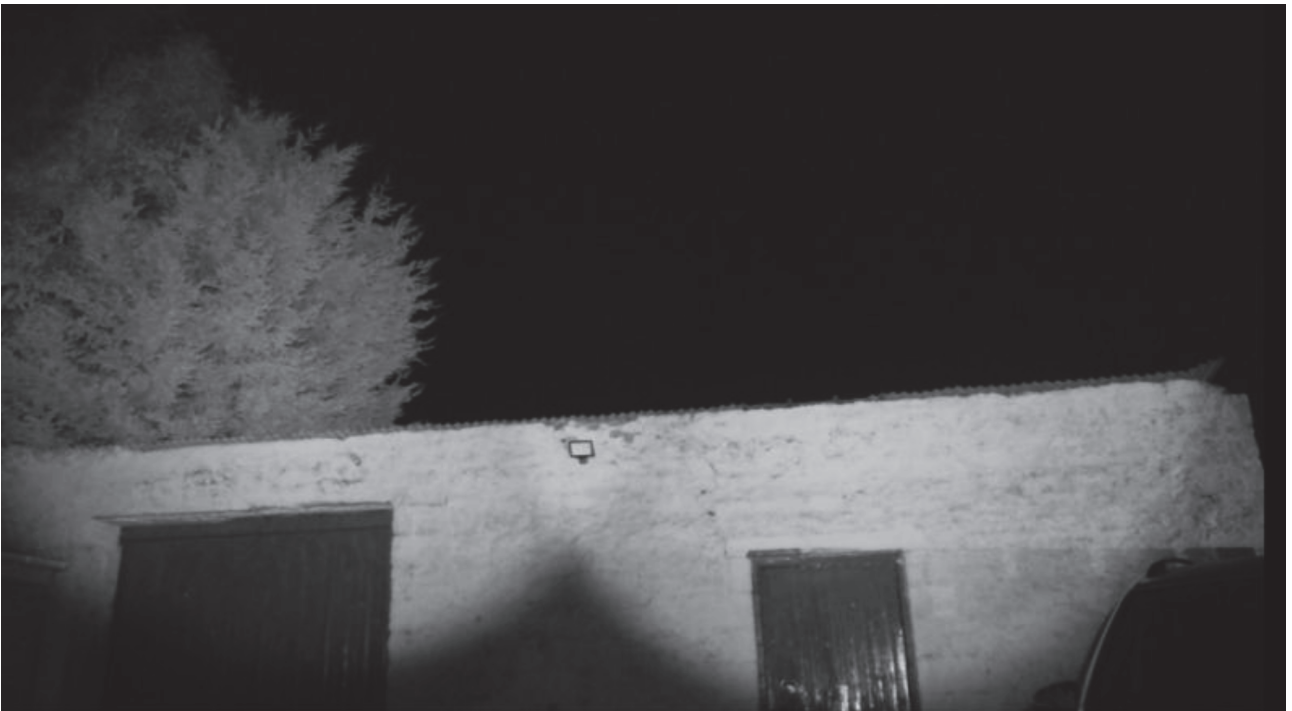
Plate 4 Screenshot from NVA to show field of view and illumination of Camera D

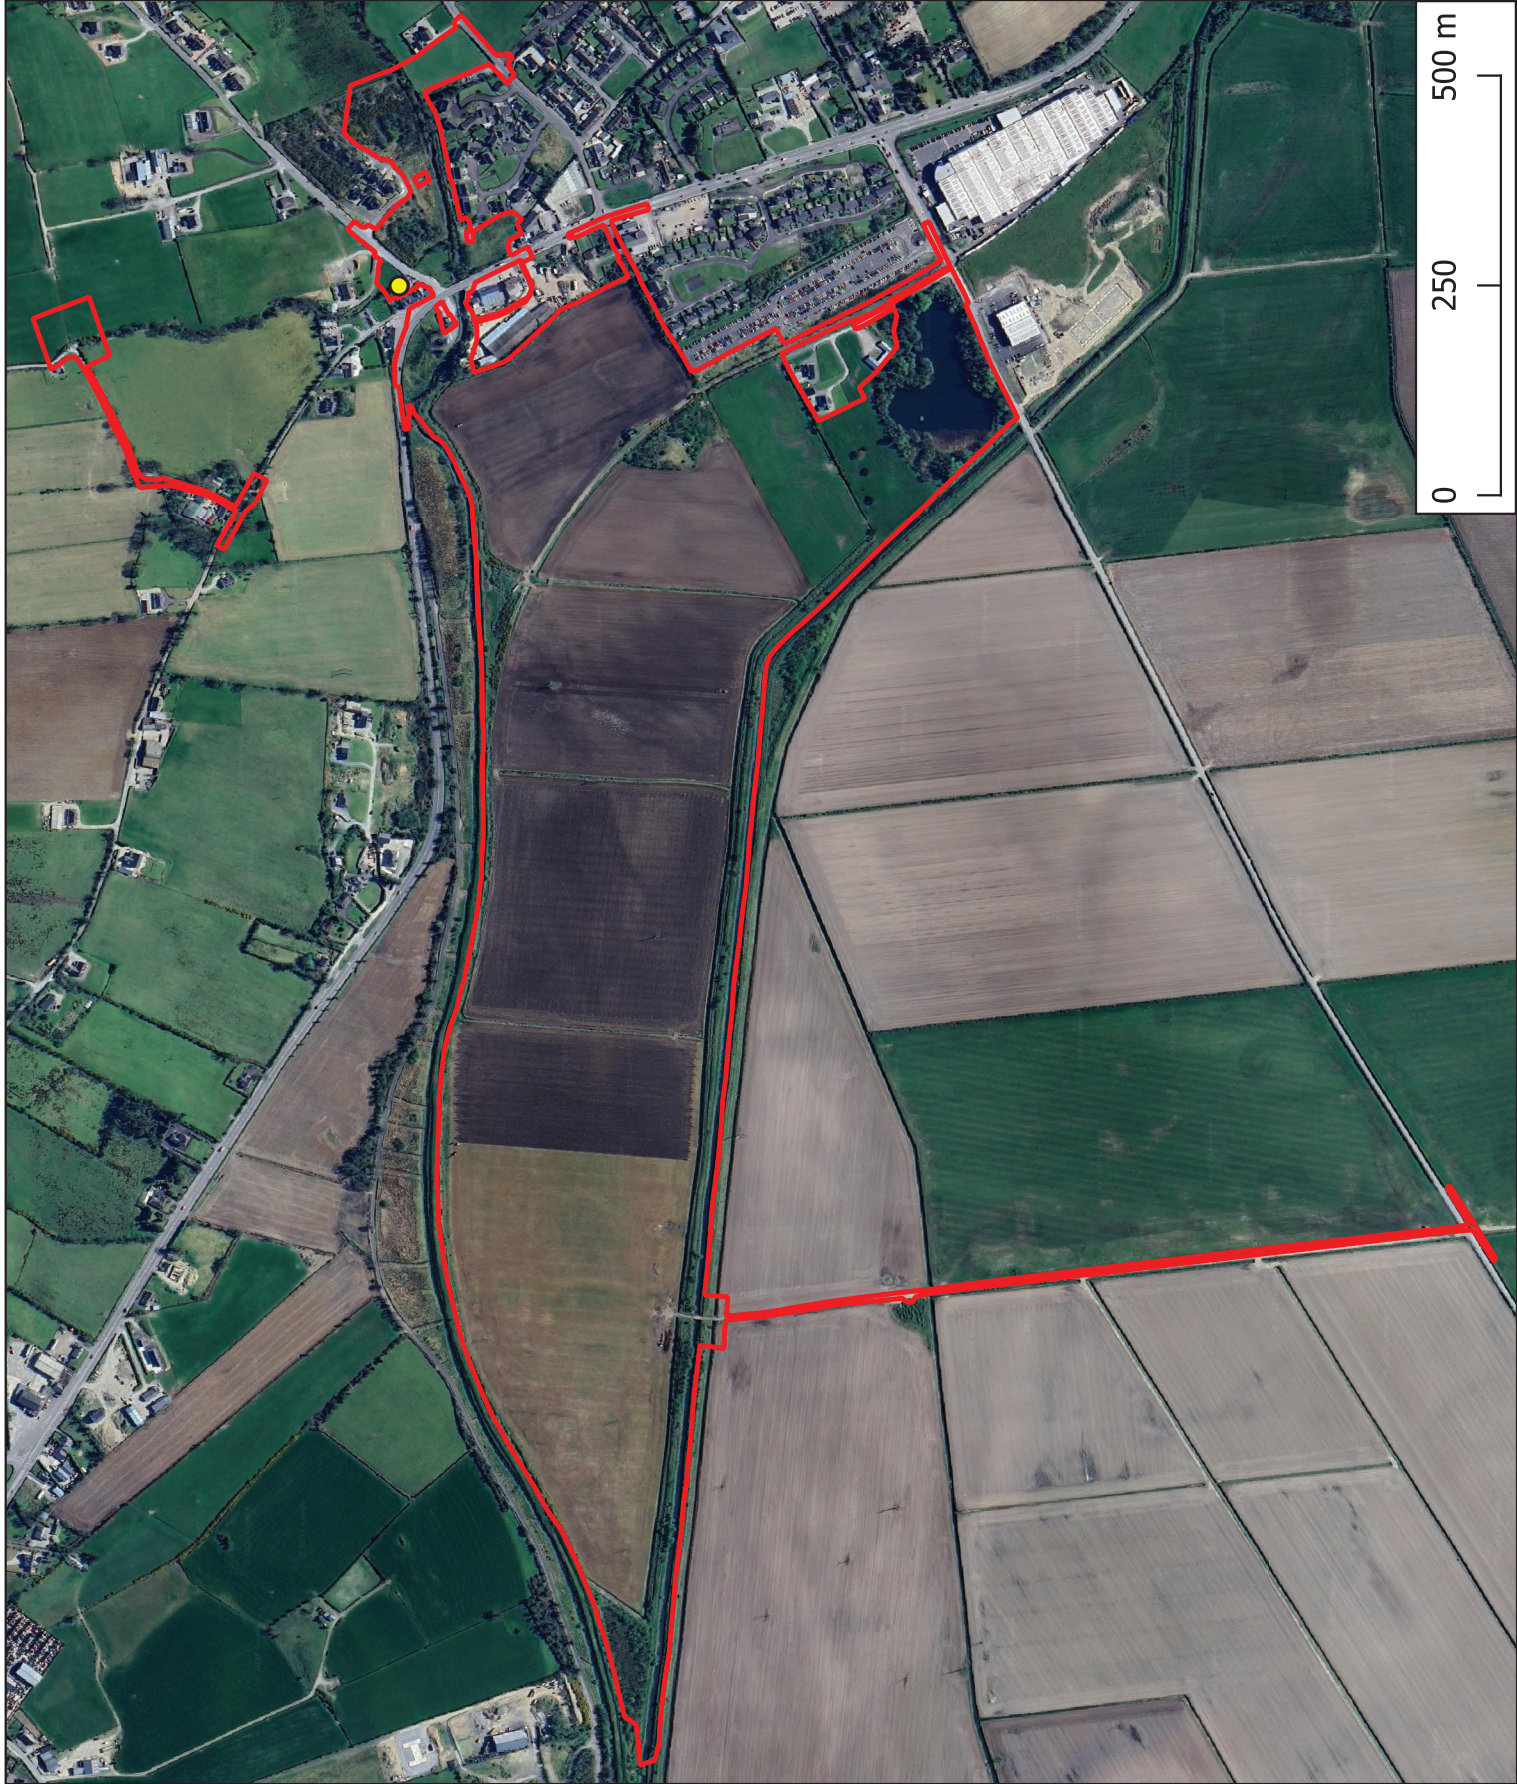
Figure 2 Location of Structures Subject to Bat Survey

- Site Boundary
- Structure 1

There is a single structure on site which is proposed to be demolished to accommodate the associated Burnfoot FRS. This structure was subject to a PRA to identify potential entry and exit points and to determine the potential suitability of the structures to provide roosting habitat for bat species. The structure is currently in relatively poor condition; however, it does provide some sheltered sections of crumbling walls and loose eaves which could be used opportunistically by individual bats. Therefore Structure 1 was considered of Low suitability to provide roosting habitat for bats. Full details of the PRA can be found in **Appendix B** of this report. The location of the structure can be found in **Figure 2**.

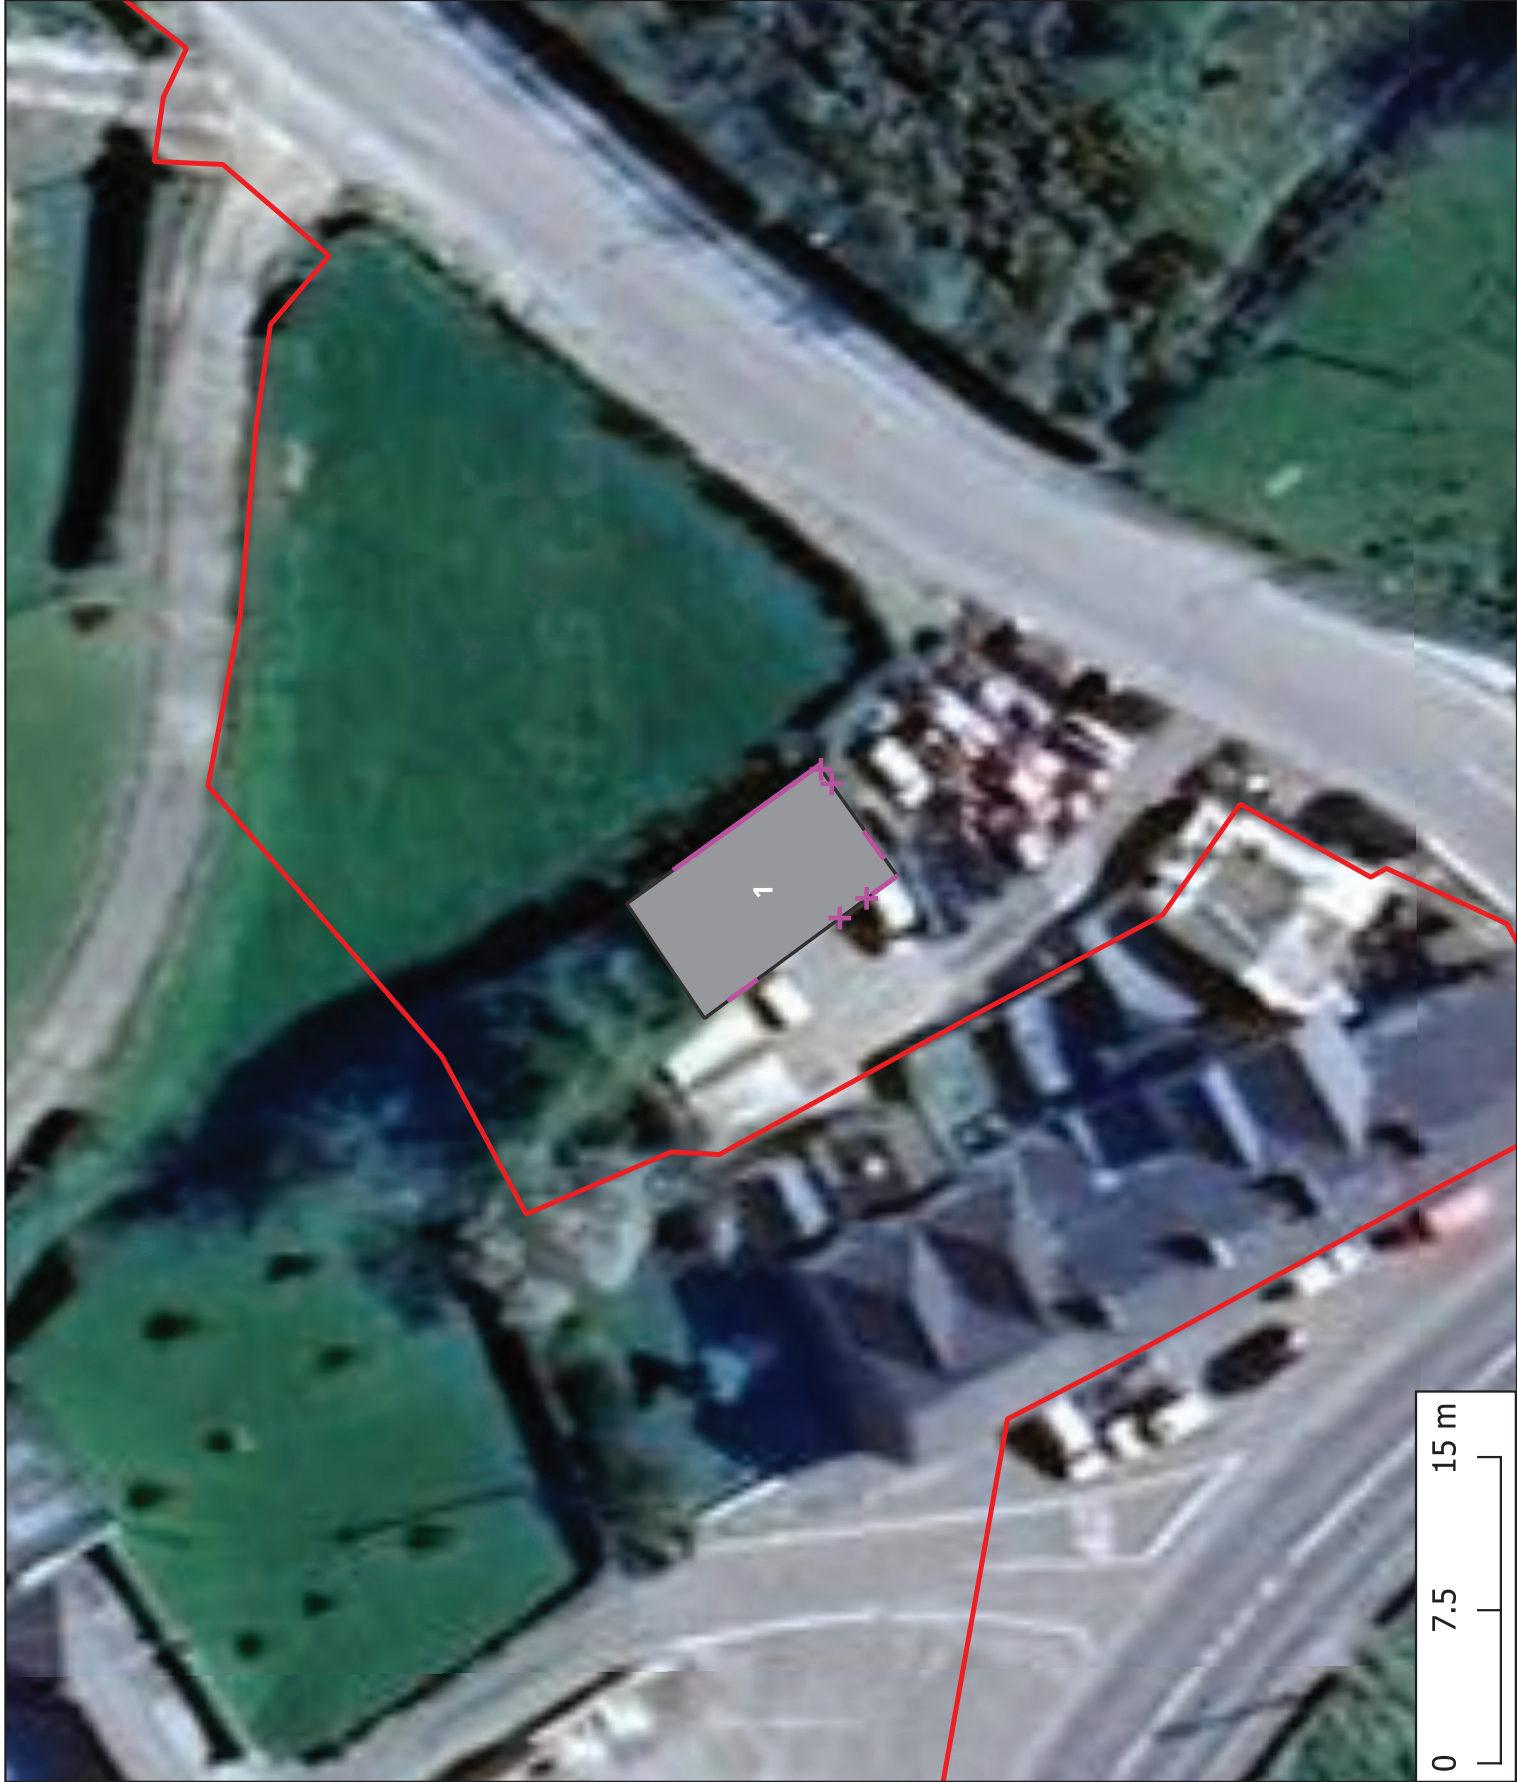
Figure No. 3.0

Figure 3 Bat Survey (S1) 16.06.2025

A single dusk emergence survey was carried out on Structure 1 in July 2025. The location and field of view of NVAs can be found in **Figure 3**. A screenshot from each camcorder taken during the darkest point in the survey to illustrate the field of view and visibility can be found in **Plates 1-2**. **Table 1** below provides the results of the emergence survey.
